**Kings Deer HOA
Monument, CO**

Report #: 13409-0
Beginning: January 1, 2022
Expires: December 31, 2022

**RESERVE STUDY
"Full"**

August 20, 2021

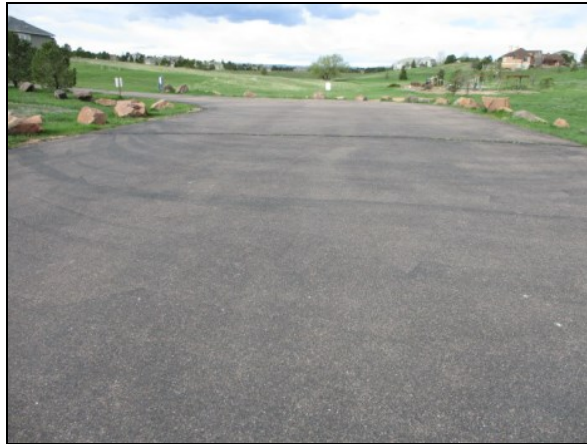
Comp #: 21190 Asphalt - Seal/Repair

Useful Life:
4 years

Remaining Life:
0 years

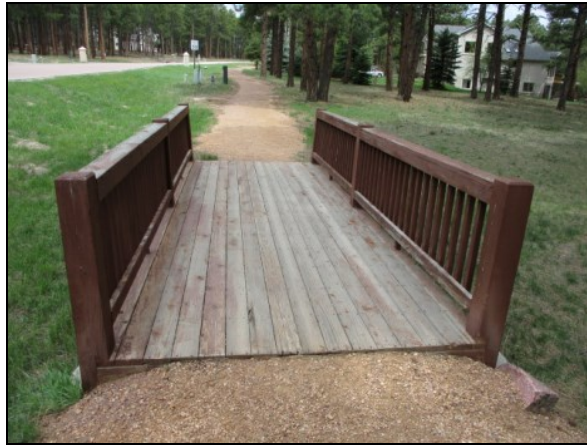
Comp #: 21240 Bridge - Replace Deck/Rails

Useful Life:
25 years

Remaining Life:
18 years

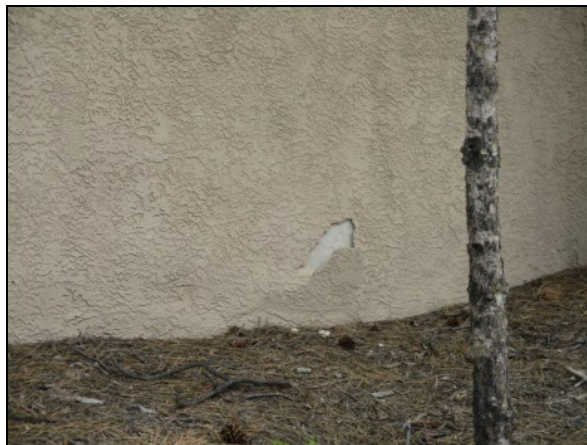
Comp #: 21390 Stucco Walls – Repair/Paint

Useful Life:
15 years

Remaining Life:
4 years

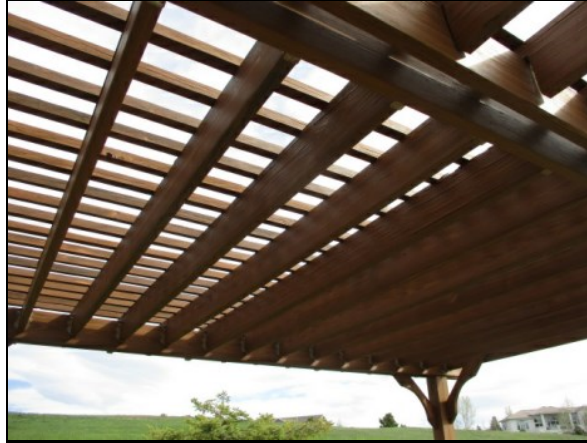
Comments: Pergola structures determined to be in good condition typically exhibit good consistent finishes or coatings and all frame members and hardware appear to be strong and sturdy. Appearance is good and upholding aesthetic standards of the development.

Useful Life:
30 yearsRemaining Life:
22 years

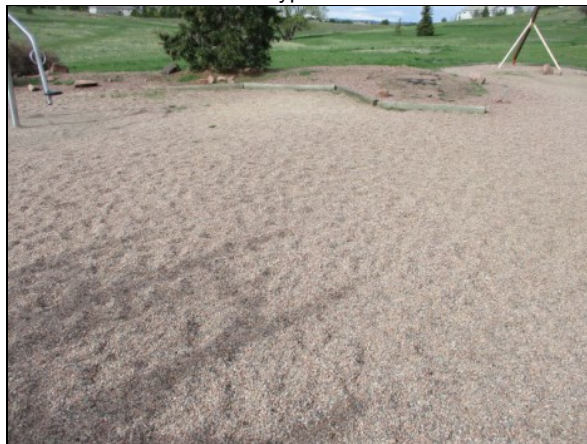
Comments: Coverage was generally sufficient but small areas of heavy use were noted. Playground surfaces should be inspected regularly for hazards slip and fall risks etc. Plan to replace at the approximate interval shown here for aesthetic and functional reasons. When evaluating replacement options the client should consult with vendors to ensure adequate protection from falls. Costs shown are based on replacement with same surface type unless otherwise noted.

Useful Life:
15 yearsRemaining Life:
10 years
