Kings Deer HOA
Monument, CO

Report #: 13409-2
Beginning: January 1, 2025
Expires: December 31, 2025

RESERVE STUDY
Update "With-Site-Visit"

August 14, 2024

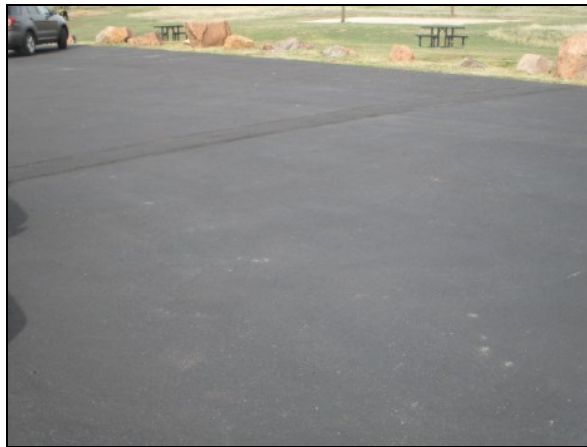
Comp #: 21190 Asphalt - Seal/Repair

Useful Life:
4 years

Remaining Life:
1 years

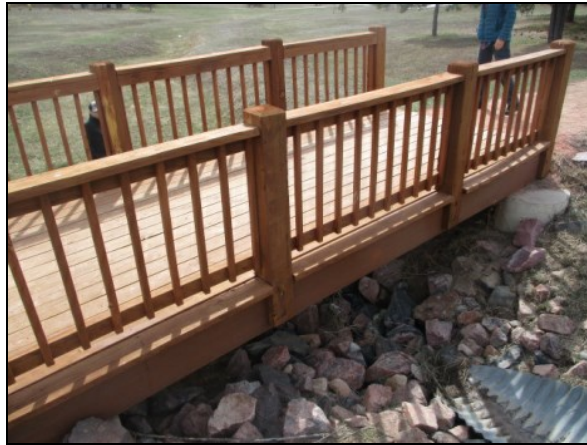
Comp #: 21240 Bridge - Replace Deck/Rails

Useful Life:
25 years

Remaining Life:
21 years

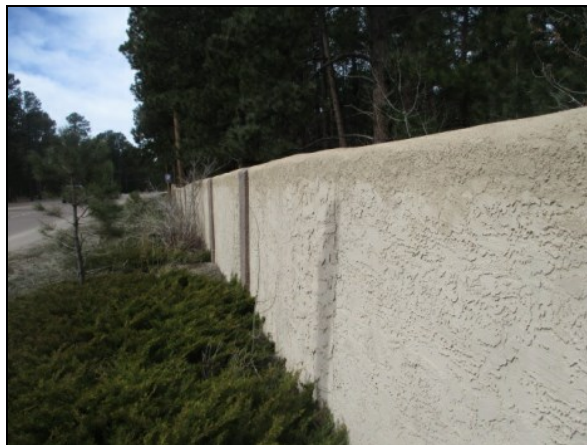
Comp #: 21390 Stucco Walls – Repair/Paint

Useful Life:
15 years

Remaining Life:
1 years

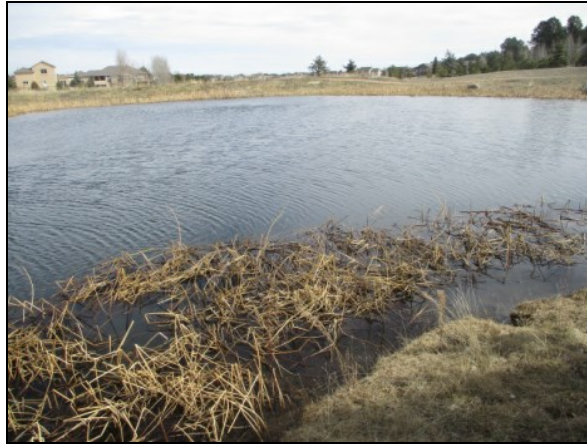
Comp #: 21540 Pond - Liner Replace

Useful Life:
50 years

Remaining Life:
30 years
